Public Infrastructure and Sustainable Urban Mass Housing in Nigeria

To cite this article: Okpoechi, C. U., Ebiringa, C. N., Ibemere L. C., & Emma-Ochu, C. A. (2020). Public Infrastructure and Sustainable Urban Mass Housing in Nigeria. *African Journal of Housing and Sustainable Development*, 1(1), pp. 13-31

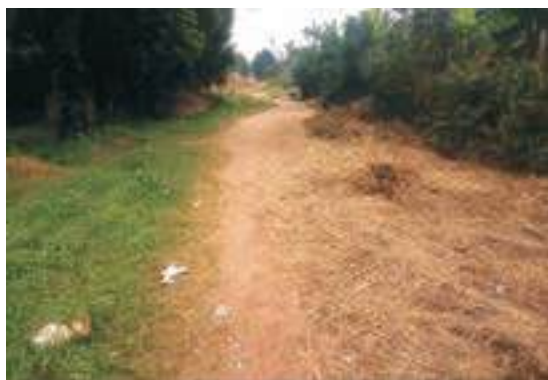
long time. The other feeder estate roads have not fared any better, as almost all of them have their top surfaces completely eroded and thus difficult to navigate through (see Plate 3). The roads were initially constructed with side drainage channels, however, as a result of a number of factors including non-conformity with the natural drainage pattern, silting, and blockages caused by waste deposits and weed, most of the drainage channels are non-functional. This has led to eroding of the hard surfacing on the roads, and flooding (see Plates 4 and 5).

Plate 3: Benedict Nwamadi Street

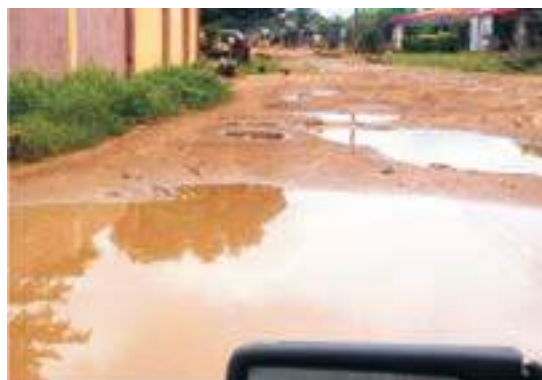
Plate 4: A flooded street with blocked gutters

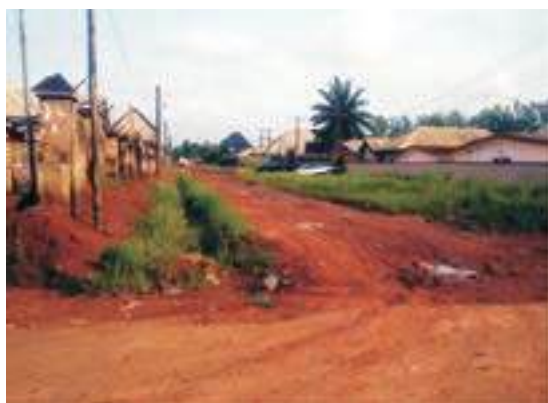
Plate 5: Chief Nnadi Street

The entire estate is connected to public power supply. Overhead power poles are seen dotting the entire estate (see Plate 5). Additionally all lots within the estate were at inception, connected to the public water works which has been non-functional for well over five years. Due to road reconstructions, most of the water pipes have been damaged or uprooted. As a result, residents have resorted to either buying water from water vendors which are discharged into storage tanks, or drilling boreholes within their properties (see Plate 6). Refuse collection in the estate is not coordinated. Residents dispose of their wastes indiscriminately at street corners, or drop them off at the refuse bin located at Dick Tiger Road. This bin is a considerable distance away from the central core of the estate, making it difficult for many households to access it. The immediate vicinity of the bin is very filthy and gives off a putrid odour.

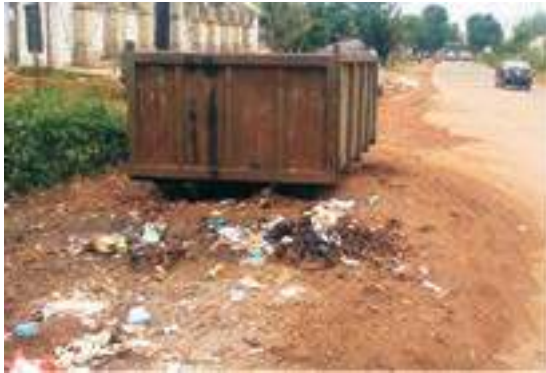
Plate 7: Refuse collection point

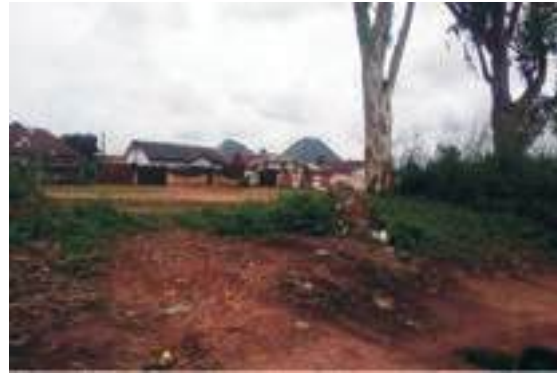
Plate 8: Open field

The communal areas identified in this estate are one nursery/primary school, and an open area which could serve as both a football field and a meeting point for communal activities and outdoor events. No other shared public spaces were seen in the estate. The school is centrally located and can be accessed from the different sections of the estate. The open area on the other hand is over-grown with weed, and appears not to have been used in a long while (see Plate 8).

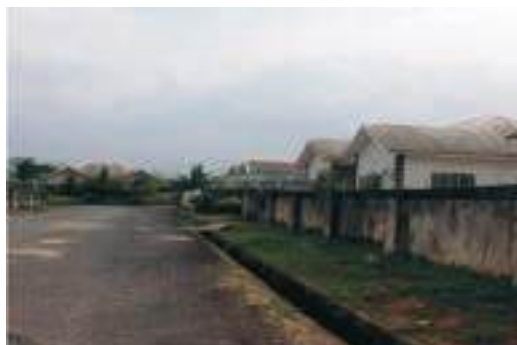
Plate 11: Fabian Osuji Street

Graceland Estate has a good network of roads, ensuring access to all sections of the estate. The roads are provided with side drains to help in the discharge of storm water after the rains. Some of the drains are blocked, and residents report substantial flooding of the estate when it rains (see Plates 11, 12, and 13).

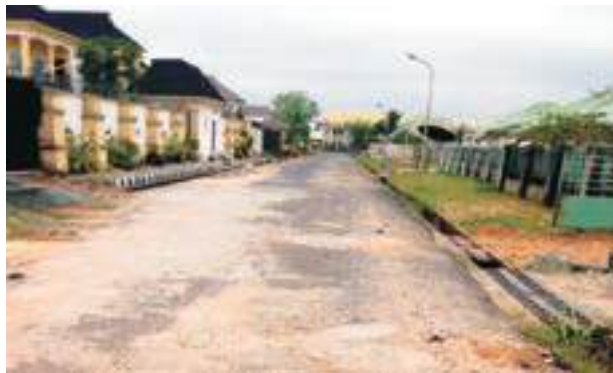
Plate 12: Road showing patched up areas

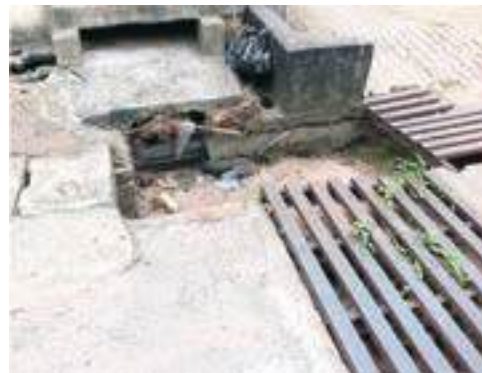
Plate 13: Blocked and broken drain

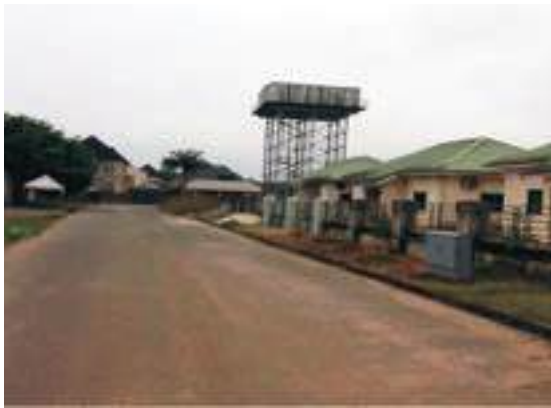
Plate 14: Overhead tank

An in-house articulated water supply system is used in the estate. A central overhead tank serves the entire estate and supplies the individual housing units. Some houses have private tanks for water storage. Electricity supply is from the public mains, fed through transformers provided in the estate. Residents augment the erratic supply with private power generating sets.

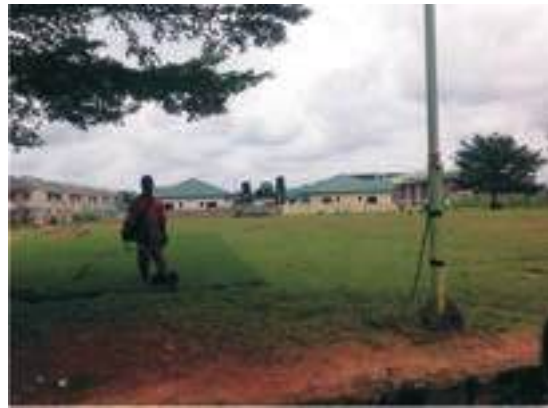
Plate 15: Open field for outdoor activities

Graceland estate has a number of facilities for communal activities and recreation. These include an open field for outdoor activities, a shopping mall, an events centre, and a hotel still under construction (see Plates 15, 17 and 18). There are churches and schools outside the estate, but near enough for use by the residents.

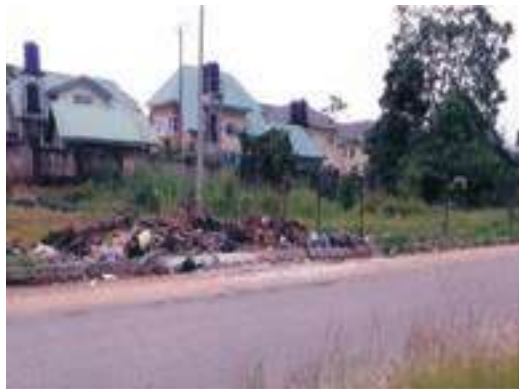
Plate 16: Refuse dump on the main road

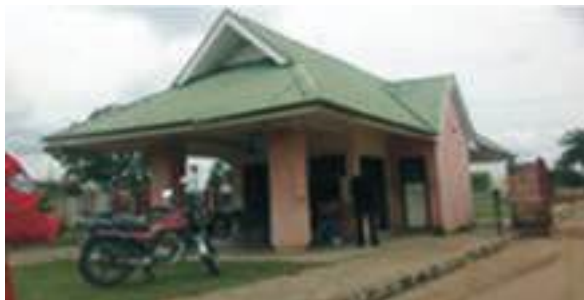
Plate 19: Security gate

The estate has a concrete perimeter fence around it and a security gate with personnel who work shifts. In addition, there are mobile police men who patrol the estate day and night on foot and with motorcycles. There are street lights all around the estate for illumination at night.

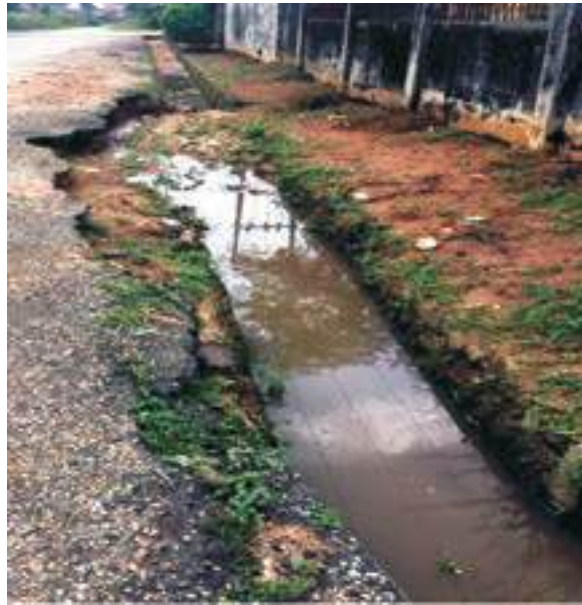
Plate 21: Eze Nwachukwu Udeaku Street

Corporation. This service is no longer operational, leaving residents with no other option than to make private arrangements for water supply, which include drilling boreholes or sourcing water from water vendors. Some residents have water discharge points in their properties which they use to supply water to other residents as a commercial venture. Refuse disposal within the estate is uncoordinated. Residents dump wastes generated from their houses indiscriminately on roads and street corners. Disposal trucks are seen at irregular intervals carting away refuse from Chukwuma Nwoha Road, leaving internal roads and street corners. The dump sites end up dirty, smelly, and unsightly. The roads and gutters are not cleaned, as there is no operational estate maintenance outfit. As a result, the entire estate is strewn with refuse and overgrown with weed (see Plates 21, 22, and 25).

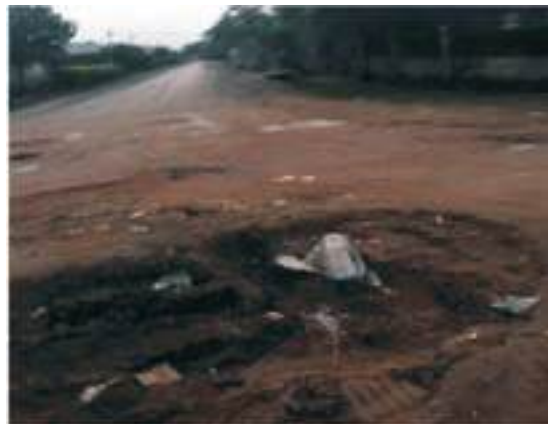
Plate 23: Estate road eroded by rainwater

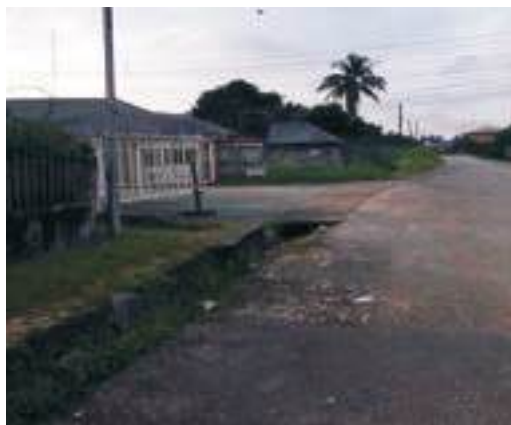
Plate 24: Weed overgrowth by the sides of the road

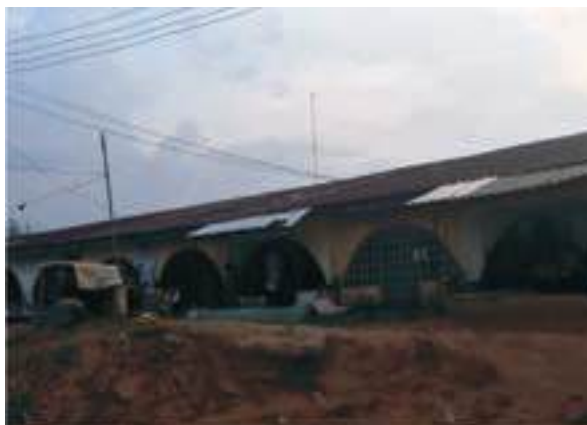
Plate 25: Flood activity in front of the commercial centre

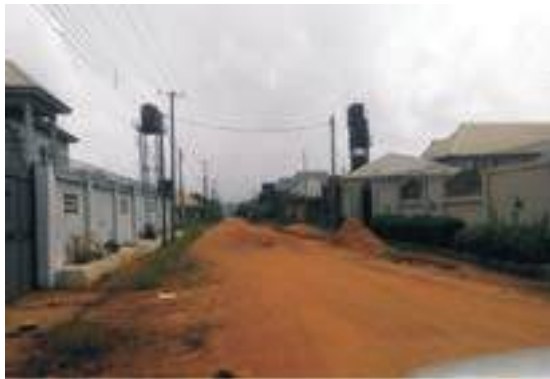
The main access road into the estate is in a serious state of disrepair. Although there is a good network of roads within the estate, however almost all the roads are earth roads with no hard surfacing.

Plate 28: Earth road in the estate

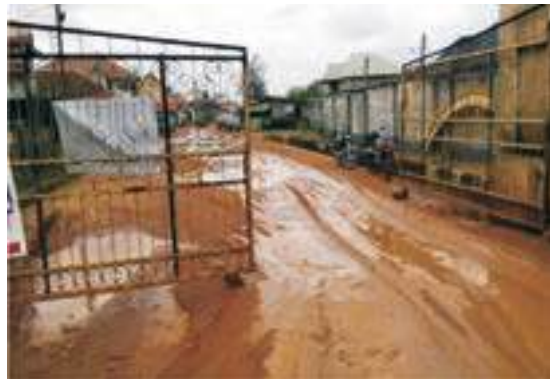
Plate 29: Muddy road at the entrance of the estate

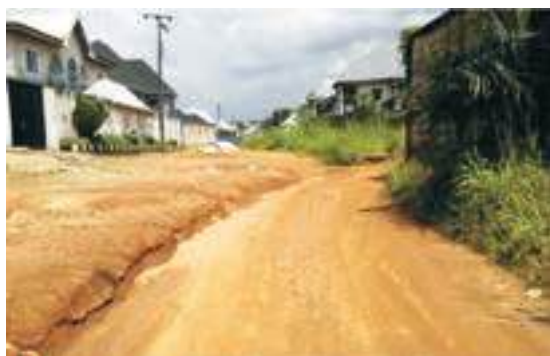
Plate 30: Road badly eroded by water

This makes it difficult to ply the roads both in the rainy season and the harmattan season. To compound the road problem, most sections of the estate, especially the area for the higher middle class, do not have drainage channels for storm water drainage. Consequently, the roads are flooded and develop potholes during the rainy season. Some roads are also eroded for the same reason.

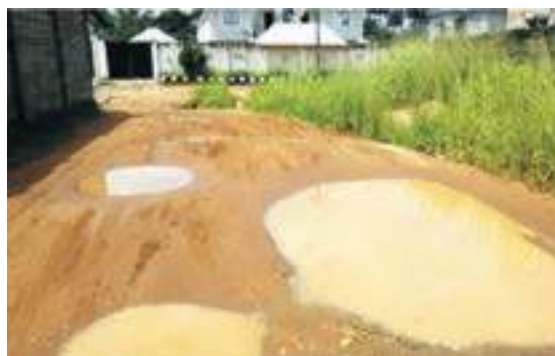
Plate 31: Potholes on the road

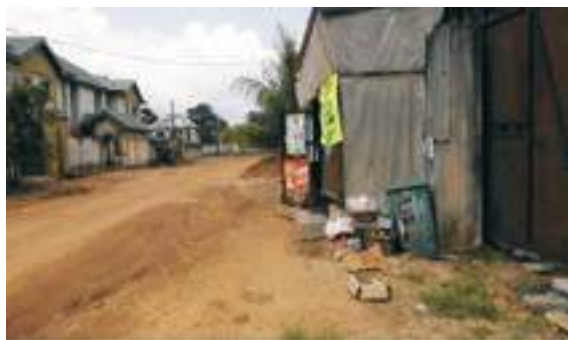
Electric supply into the estate is from the public supply source, and as reported by the residents, very erratic. As with the other estates, private sources of power supply are employed by residents. There is no articulated water supply in the estate. Individual households drill boreholes, and with pump and overhead tank system, provide potable water to their homes. Overhead tanks are visible in Plate 28. There is no coordinated refuse management system in the estate. Residents bag their household wastes and drop them off in nearby bushes, and sometimes by the sides of the road (see Plates 32 and 33). Some other residents arrange with private refuse disposal companies, who are paid for picking up the refuse at their door steps.

Plate 32: Refuse scattered in front of a building with a shop front

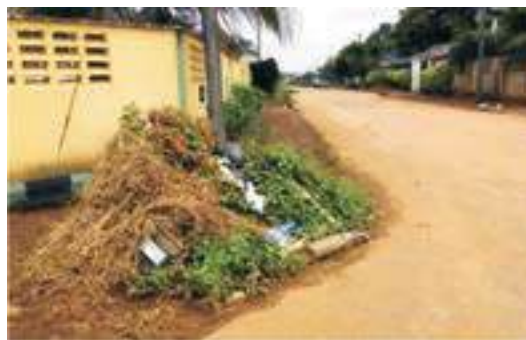
Plate 33: Heap of dirt on the road

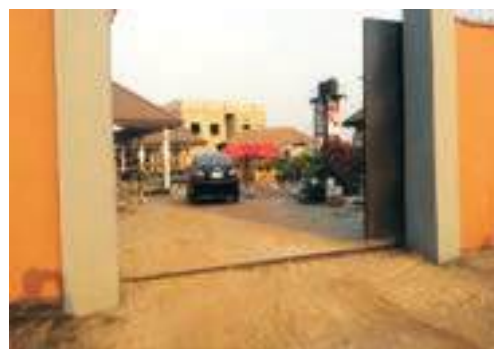
There is no clearly marked out shopping centre in the estate. Some residents provide shops in their residences to fill the gap (see Plate 34). This largely distorts the original concept of the estate. There are three privately owned nursery and primary schools. However, these schools do not have adequate spaces for playground for the children. There is no secondary school in the estate. There are a number of churches in the estate, used by the estate residents. There is a privately owned relaxation centre in the estate, used mostly for relaxation, entertainment and meetings by the residents. There is no open field for sports and recreation.

Plate 35: Residences turned to shops

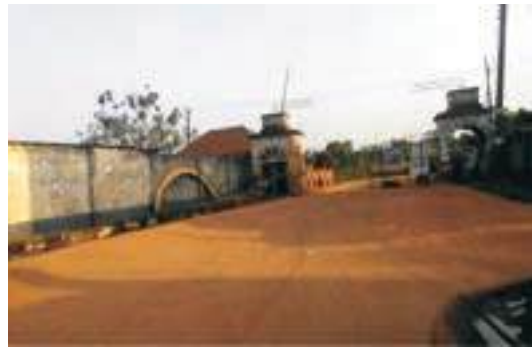
Plate 37: The main gate into the estate

There is perimeter fencing over large portions of the estate. There are two security gates into the estate from the main access road that connects Onitsha Road to Orlu Road. All security arrangements in the estate are by residents who engage private security personnel to keep watch in the absence of formal police presence. There are no street lights in the estate, making it always dark at night.
